High Rise Buildings
Glass rectification & Protection
Glass contaminations

Project: Pinnacle Apartments, Dind Street, Milsions Point
Owner: Sydney, Australia
Company: Multiplex
Product supply : Nanovations Pty Ltd
Contractor: Karabiner Access Pty Ltd , Alexandria ,Australia
Year: 2007/2008

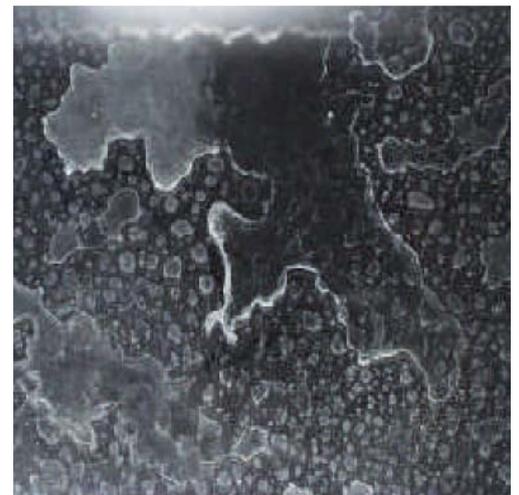
The Pinnacle Apartments in North Sydney are a prestigious residential development. While its proximity to the harbour and CBD offer amazing views, it suffers from intense exposure to the elements and big city pollution problems. Over time these conditions have caused such a severe build up of contaminants on the glass, views through the windows have been largely obscured. Additional leaching from the rendered facade elements that collected the pollution and salt spray created contaminations on the glass which is extremely stubborn and hard to remove.

Typical glass condition at the Pinnacle

Rectification- Over a period of nearly 3 years numerous different methods have been used and some attempts have damaged the glass leaving deep scratches. Not deterred, KA and Nanovations have pulled out all stops to find an efficient cleaning method. After seeking further assistance from their scientists partner and working with the KA crew and a compound removal process was developed that did not damage the glass.

Protection - Several glass protection coatings were applied on sample windows after the cleaning to test the durability and protective properties over a period of time. The best performing glass treatment was a product based on a new technology and supplied by Nanovations Pty Ltd.

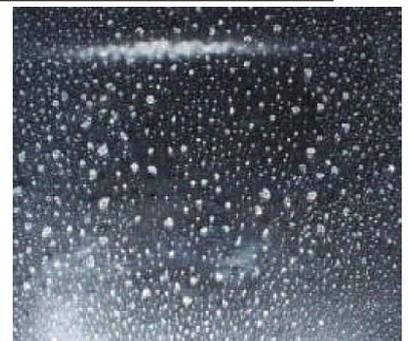
Test area with mineral contamination

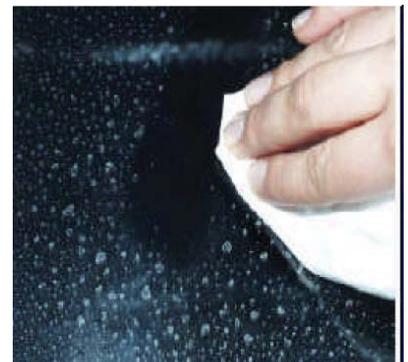
Calcium shows weak bond and can be removed with a micro fiber cloth.

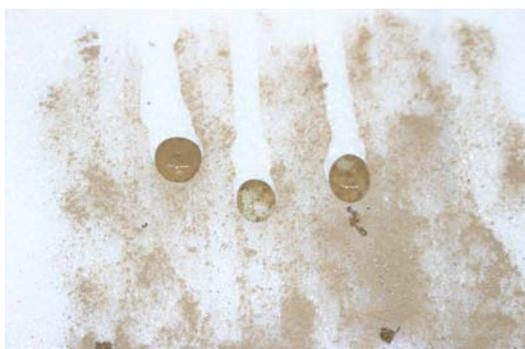
Water droplets pick up dust and dirt from a treated test panel. (self cleaning effect)

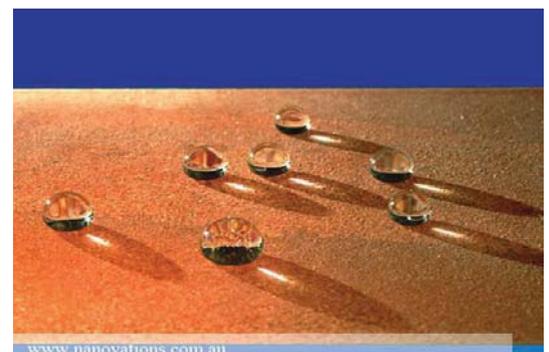
Hydrophobic effect on test panel
